CALSPAN ON-SITE AIR BAG DEPLOYMENT INVESTIGATION

CALSPAN CASE NO. 91-14

FLEET - 1992 PLYMOUTH ACCLAIM

ACCIDENT DATE - [REDACTED] 1991

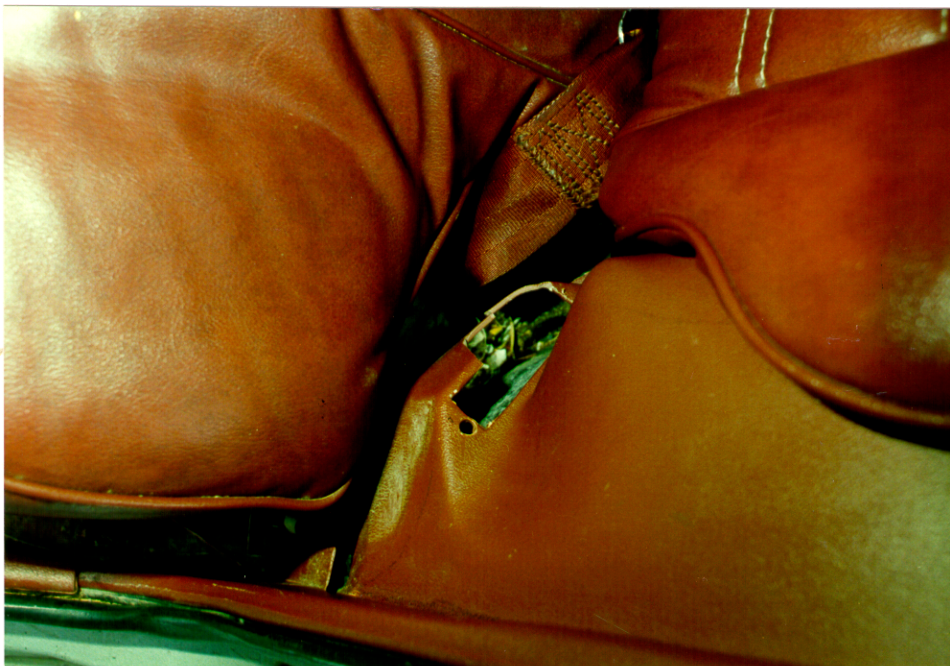
It was remotely possible that her head impacted the upper right quadrant of the left front seat back, thus hyperflexing, resulting in the spinal cord injury. Faint transfers (tissue) were noted to the possible area of contact. The front seat assembly was displaced forward; therefore, the left rear occupant would had to have been seated on the forward edge of the rear seat cushion to impact the seat back.

Possible Left Rear Occupant's Head Contact To The Front Seatback.

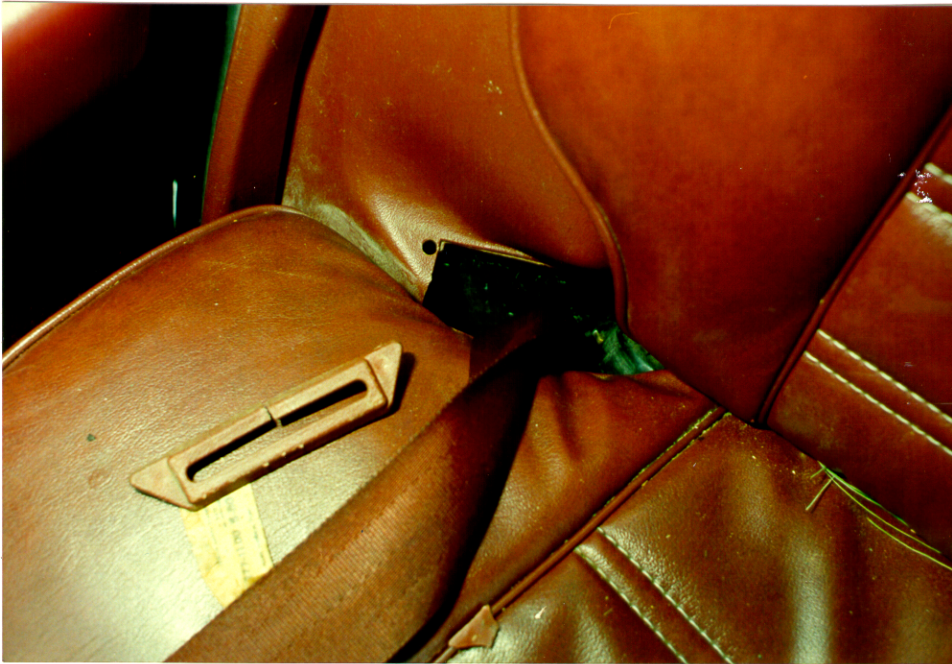
The left rear occupant was in an unknown seated position at impact. She was either holding a pet rabbit in a cardboard cage on her lap or had the cage positioned between her feet on the floor. The 6 year old occupant was wearing the lap belt that was equipped with an outboard mounted locking retractor. At impact, the passenger was thrust forward with respect to the decelerated vehicle and loaded the lap belt with her pelvic/abdominal area. Her unrestrained upper torso pitched forward which resulted in hyperextension of her head and transection of the cervical spinal cord.

Left Rear Occupant's Loading Damage To The Lap Belt Guide.
